New Jersey's Hidden Secrets

Katherine Ng, LEED AP, Vice President, Wu & Associates, Inc.

July 13, 2020

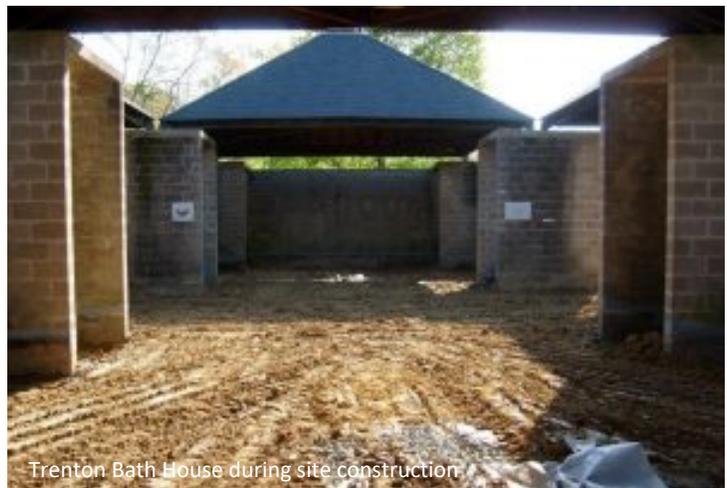
Every feature of the Trenton Bath House was meticulously studied by the design team long before our arrival. Damaged by a half-century of water infiltration soaking into the unprotected concrete masonry unit walls standing underneath the elevated roofing structures, painstaking details for a lasting restoration were provided. These details translated to several unique field endeavors for the Wu team, including the creative reproduction of the original block, the use of thermostatic coatings to prevent future infiltration, the “slap-dash” technique of mortar application, the sourcing of terra cotta elements, and the procurement of sinker cypress wood.

The one significant surprise that arose during construction was what lay beneath the failing concrete slabs beneath the building. Upon removal of these slabs, a high water-table was uncovered as the source for the failure due to the Delaware River flowing just two miles down the road. After extensive analysis, the design team crafted an elaborate solution involving new wells, geotextile fabric, crushed stone, and trenches for storm and drain upon which the new foundation was laid.

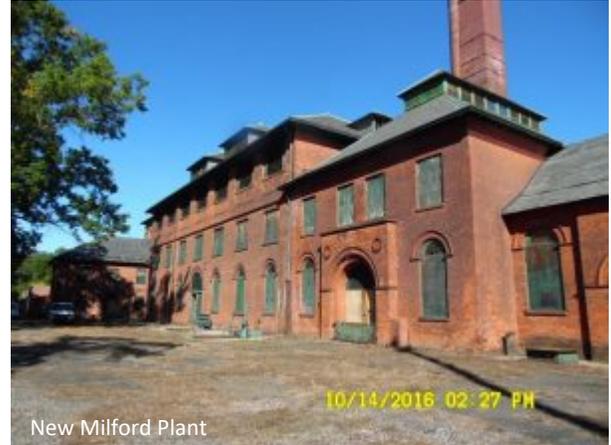
The surprise came when the existing conditions of the structure were significantly more deteriorated than what was previously documented. Due to the large span of time that passed since the initiation of design years prior to the start of construction, the building was subjected to the relentless onslaught of natural elements which further compromised the structure. Additional work was required for the increased number of purlins needing work; the unique requirements necessary for the slate shingles unknown until the existing shingles were removed; and areas of brick that were failing.

When the Wu team arrived onto the site in 2016, our mission was to focus on structural stabilization. Many of the repairs involved the installation of new purlins to support the roof rafters, along with the sistering of old purlins. Other work involved slate roofing, brick repair, and window protection.
