CMU HISTORIC PRESERVATION

# *Kahn Bathhouse*

After a swim, 1955's Jewish Community Center members pass the structure's variegated block walls to enter its tranquil changing-rooms. Today, as the Ewing County Center for Seniors & Youth, it's a rare example of a restored landmark that still serves its original function.

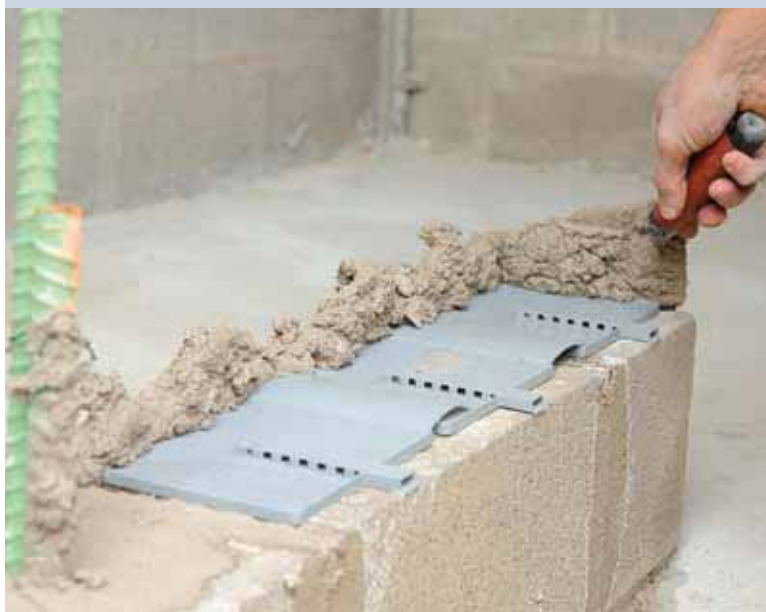
**Correcting Kahn’s flashing omission with hidden 2010 technology, one of Cavalieri’s masons grouts the flashing system into place.**

Since water had caused the Bath House's downfall, Michael Mills specified a couple of technologically advanced products (invisible, of course) to address those moisture-control problems. At the bases of the walls exposed to roof-runoff, Mills used a uniquely engineered proprietary flashing system. It consists of tough, lightweight "flashing pans" that are laid atop the first above-grade course of CMU and grouted into place. They intercept the water as it runs down the CMU's cores and expel it through integrated, unobtrusive drainage spouts. To capture mortar droppings, proprietary feather-light

mesh squares can be swiftly inserted into the cores of the next course of CMU, replacing awkward pea-gravel.

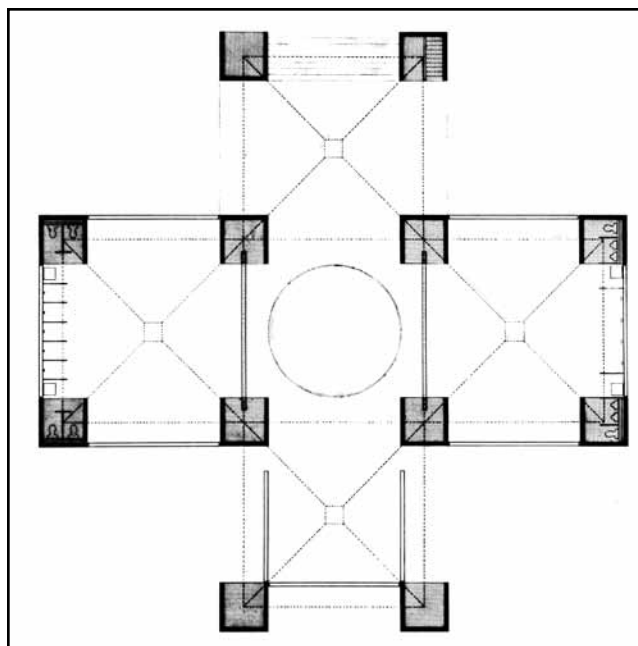
**This image shows the Bath House’s classic “Greek cross” design. In two places, the edges of the suspended roofs are flush with the devising walls beneath them. Kahn envisioned rainwater pouring romantically down the unsealed, unflashed walls. It did—leading to premature wall-failure.**

Two 28 foot (8.53 m) long demising walls, located where rain-water had poured directly onto them from the gutterless roofs—perhaps to let it run down the exterior in a “poetic” manner—were in dreadful shape. The top course of block had crumbled, and the walls were cracked from top to bottom.. “Those two walls were painful,” Cavalieri recalls. “Try as we might, very little of the original block could be salvaged.” The walls would be demolished and rebuilt using reproduced block. Salvageable units would be used as patchwork in other walls.

The corner-supports that held the raised roofs were strengthened. A gutter—connected into the building's drainage-system—was carefully concealed along the tops of the demising walls, to capture and divert the rainwater that had previously inundated the top courses of block. In building the new demising walls and replacing the unsalvageable units in the other walls, Cavalieri's masons used about 1,000 of the reproduced block-units.
